# Army Lodging Wellness Recommendation

## Final Submittal - Fort McNair

February 12, 2004

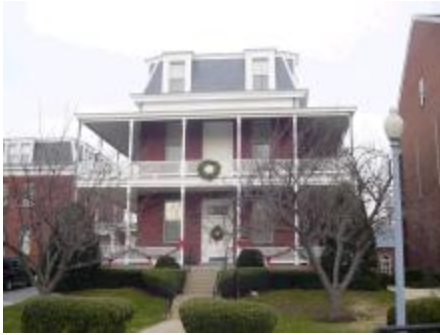
*Building 54  
Fort McNair  
Washington, D.C.*

Building 54, constructed in 1880, consists of 2 family suites and 25 standard rooms. 20 of these standard rooms have a shared bath, and most of these rooms are undersized. This facility does not meet Lodging standards and cannot be reconfigured without significant reconstruction. To renovate Building 54 to the new standards and configuration will exceed 50% of the replacement cost.

Because the Condition Assessment to Replacement Cost Ratio is greater than 50.00%, repair of Building 54 is not recommended.

Our recommendation is to remove Building 54 from the Lodging inventory, allowing the installation to determine an alternate use for this facility. This facility will be removed from the Fort McNair Wellness Solution and Lodging Master Plan.

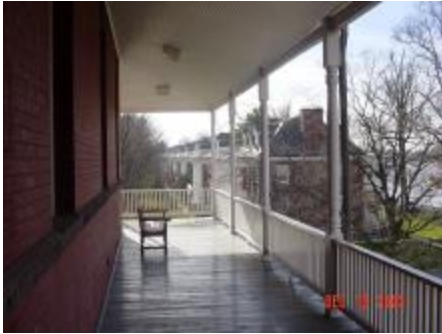
Building 54  
Second floor porch

- Analysis: The flooring consists of a first floor concrete slab supported by stone and CMU stem walls and wood framed construction with wood planked decking for the second and third floors. The first floor concrete deck was installed in the 1970's while the second and third floor system is original to the building. The system is in good condition. The exterior porch decking is tongue and groove planking and is in poor condition.
- Recommendation: No corrective action required for the interior floor system. The exterior porch decking requires repair.

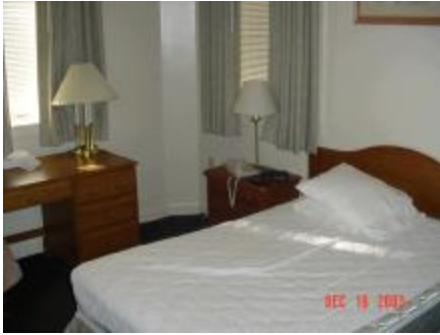
**Building 54**  
**View of typical bedroom**

- Analysis: Guest Rooms: The hard goods consist of a head board, night stand, dresser in each bedroom, a couch, easy chair, coffee table, end table, desk and entertainment shelf unit in the living rooms. All are in fair condition. Soft goods consists of drapes and blinds on the windows, TV, mattress and box springs and bed coverings. All are in fair condition.
- Recommendation: Replace all hard and soft goods in guest rooms.

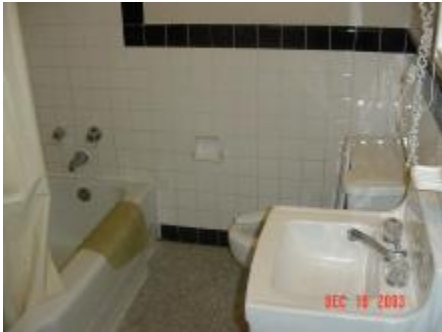
Building 54  
View of typical bathroom

- Analysis: The bathrooms contain a wall mounted lavatory, combination shower/tub and a water closet. The fixtures were installed in 1991 and are in fair condition.
- Recommendation: Replace all fixtures as part of the replacement of the domestic water system.
